Manhole Inspection Summary

Manhole # S41EE_034MH

Location Address: **1508 BIDDLE ST**

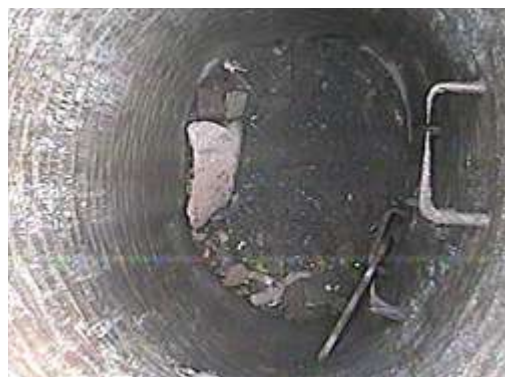
Defect 1

Count: **5** Missing: **3** ☒ **Corroded**

STEPS CORRODED

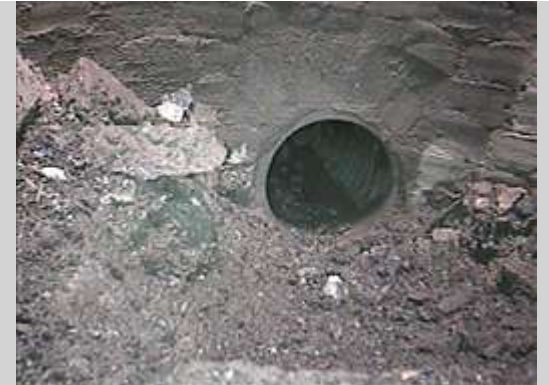
12 O'Clock Outflow

8 in. Circular Gravity Sewer
Pipe Out @ 12 O'Clock

Deposits: ☐ None ☐ Mud ☐ Sludge ☒ **Debris** ☐ Grease

Silt Depth: **2** (in.) Deposits Extent: **Medium**
